Remedial Investigation Work Plan

Equity Former MGP Site
Brooklyn, New York
NYSDEC Site No.: 224050
Order on Consent Index #: A2-0552-0606

AECOM, Inc.
July 2009
Document No.: 01765-076

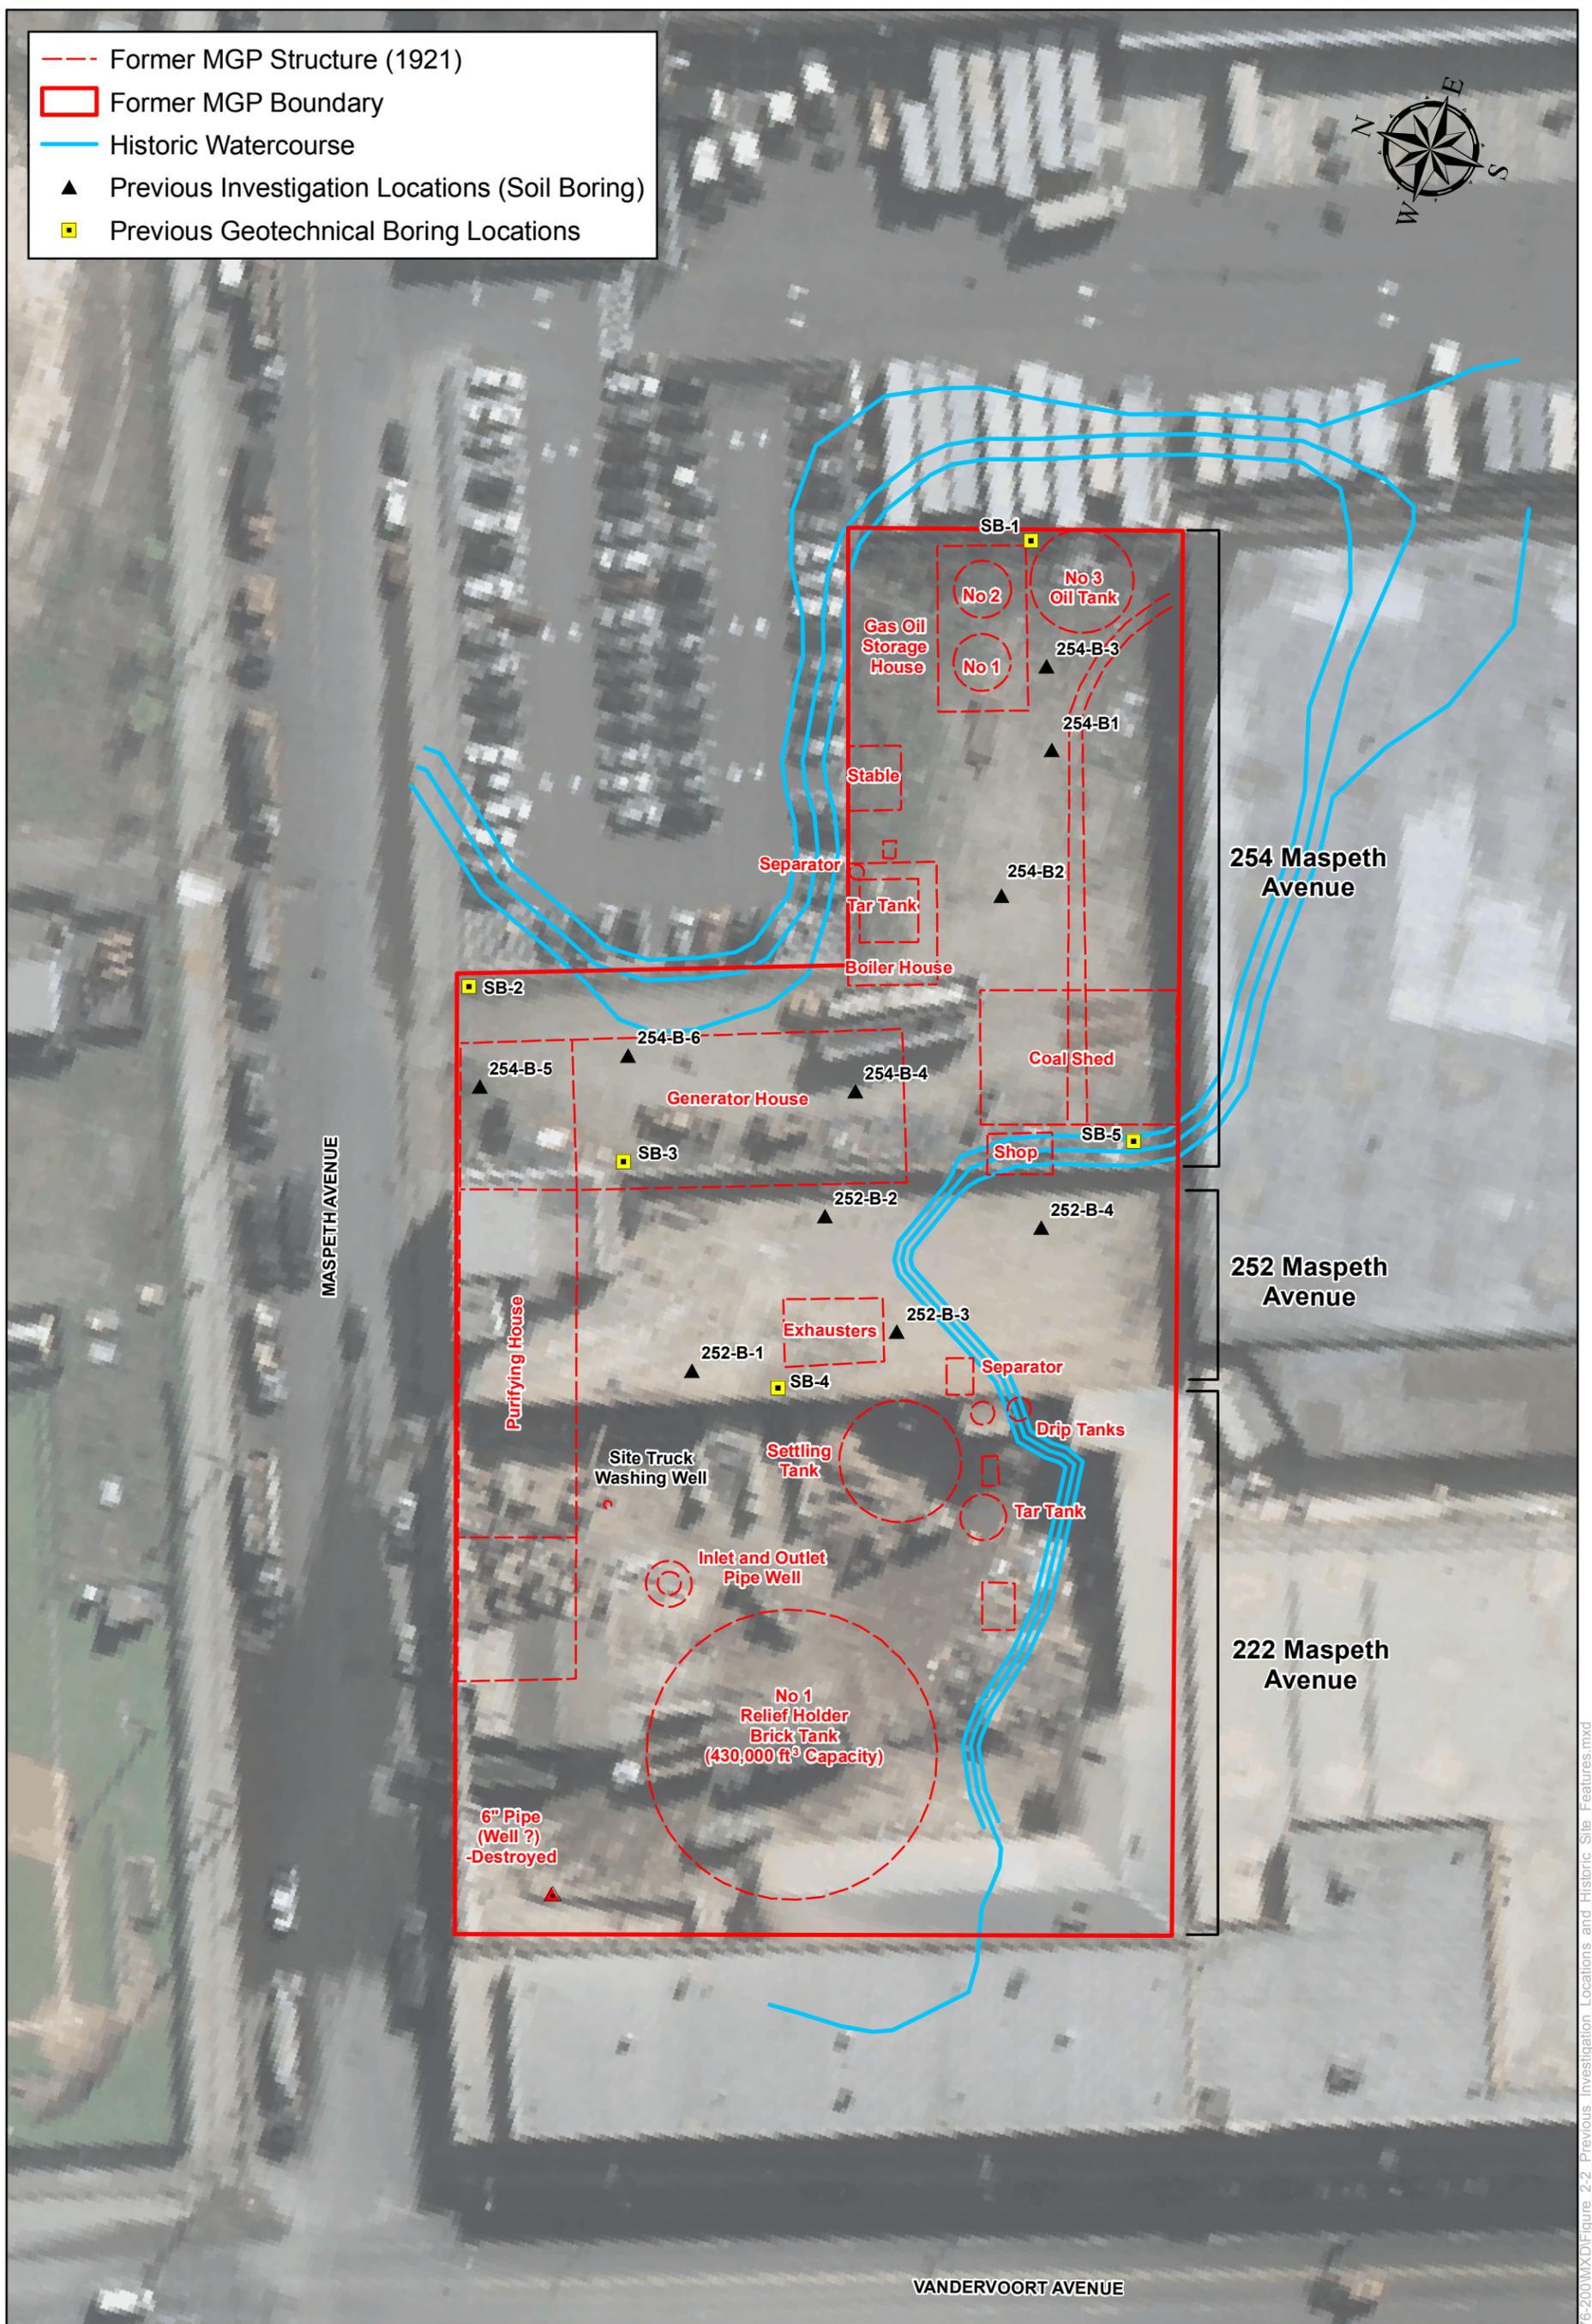
- Former MGP Structure (1921)
 - Former MGP Boundary
 - Historic Watercourse
 - ▲ Previous Investigation Locations (Soil Boring)
 - Previous Geotechnical Boring Locations
 - Medium to Strong Odors
 - Moderate to Heavy Staining & Odor
 - Visible "Oil", "Product"
- Note: # = Depth (feet Bgs) of Noted Impacts (Worst Case)

The previous investigation activities have been limited to the central (252 Maspeth Ave.) and eastern (254 Maspeth Ave.) portions of the site. Figure 2-2 illustrates the locations of previous soil borings, as well as the locations of former MGP structures, as currently understood by National Grid. Figure 2-3 provides a summary of field impacts (odors, staining, visible impacts) noted during the previous investigations. In summary, moderate to heavy staining and odors were observed within the fill unit to depths of approximately 12 to 15 feet bgs. Despite the noted staining and odors, photoionization detector (PID) readings were generally low (0-5 parts per million). Moderate to strong odors and visible impacts described as "black sand oil", "oil", and "visible product" were noted at three geotechnical borings (SB-2, SB-3, and SB-5) at depths of 21 to 24 feet bgs, 29 to 31 feet bgs, and 14 to 16 feet bgs, respectively. The maximum depth of the geotechnical borings was 31 feet bgs.

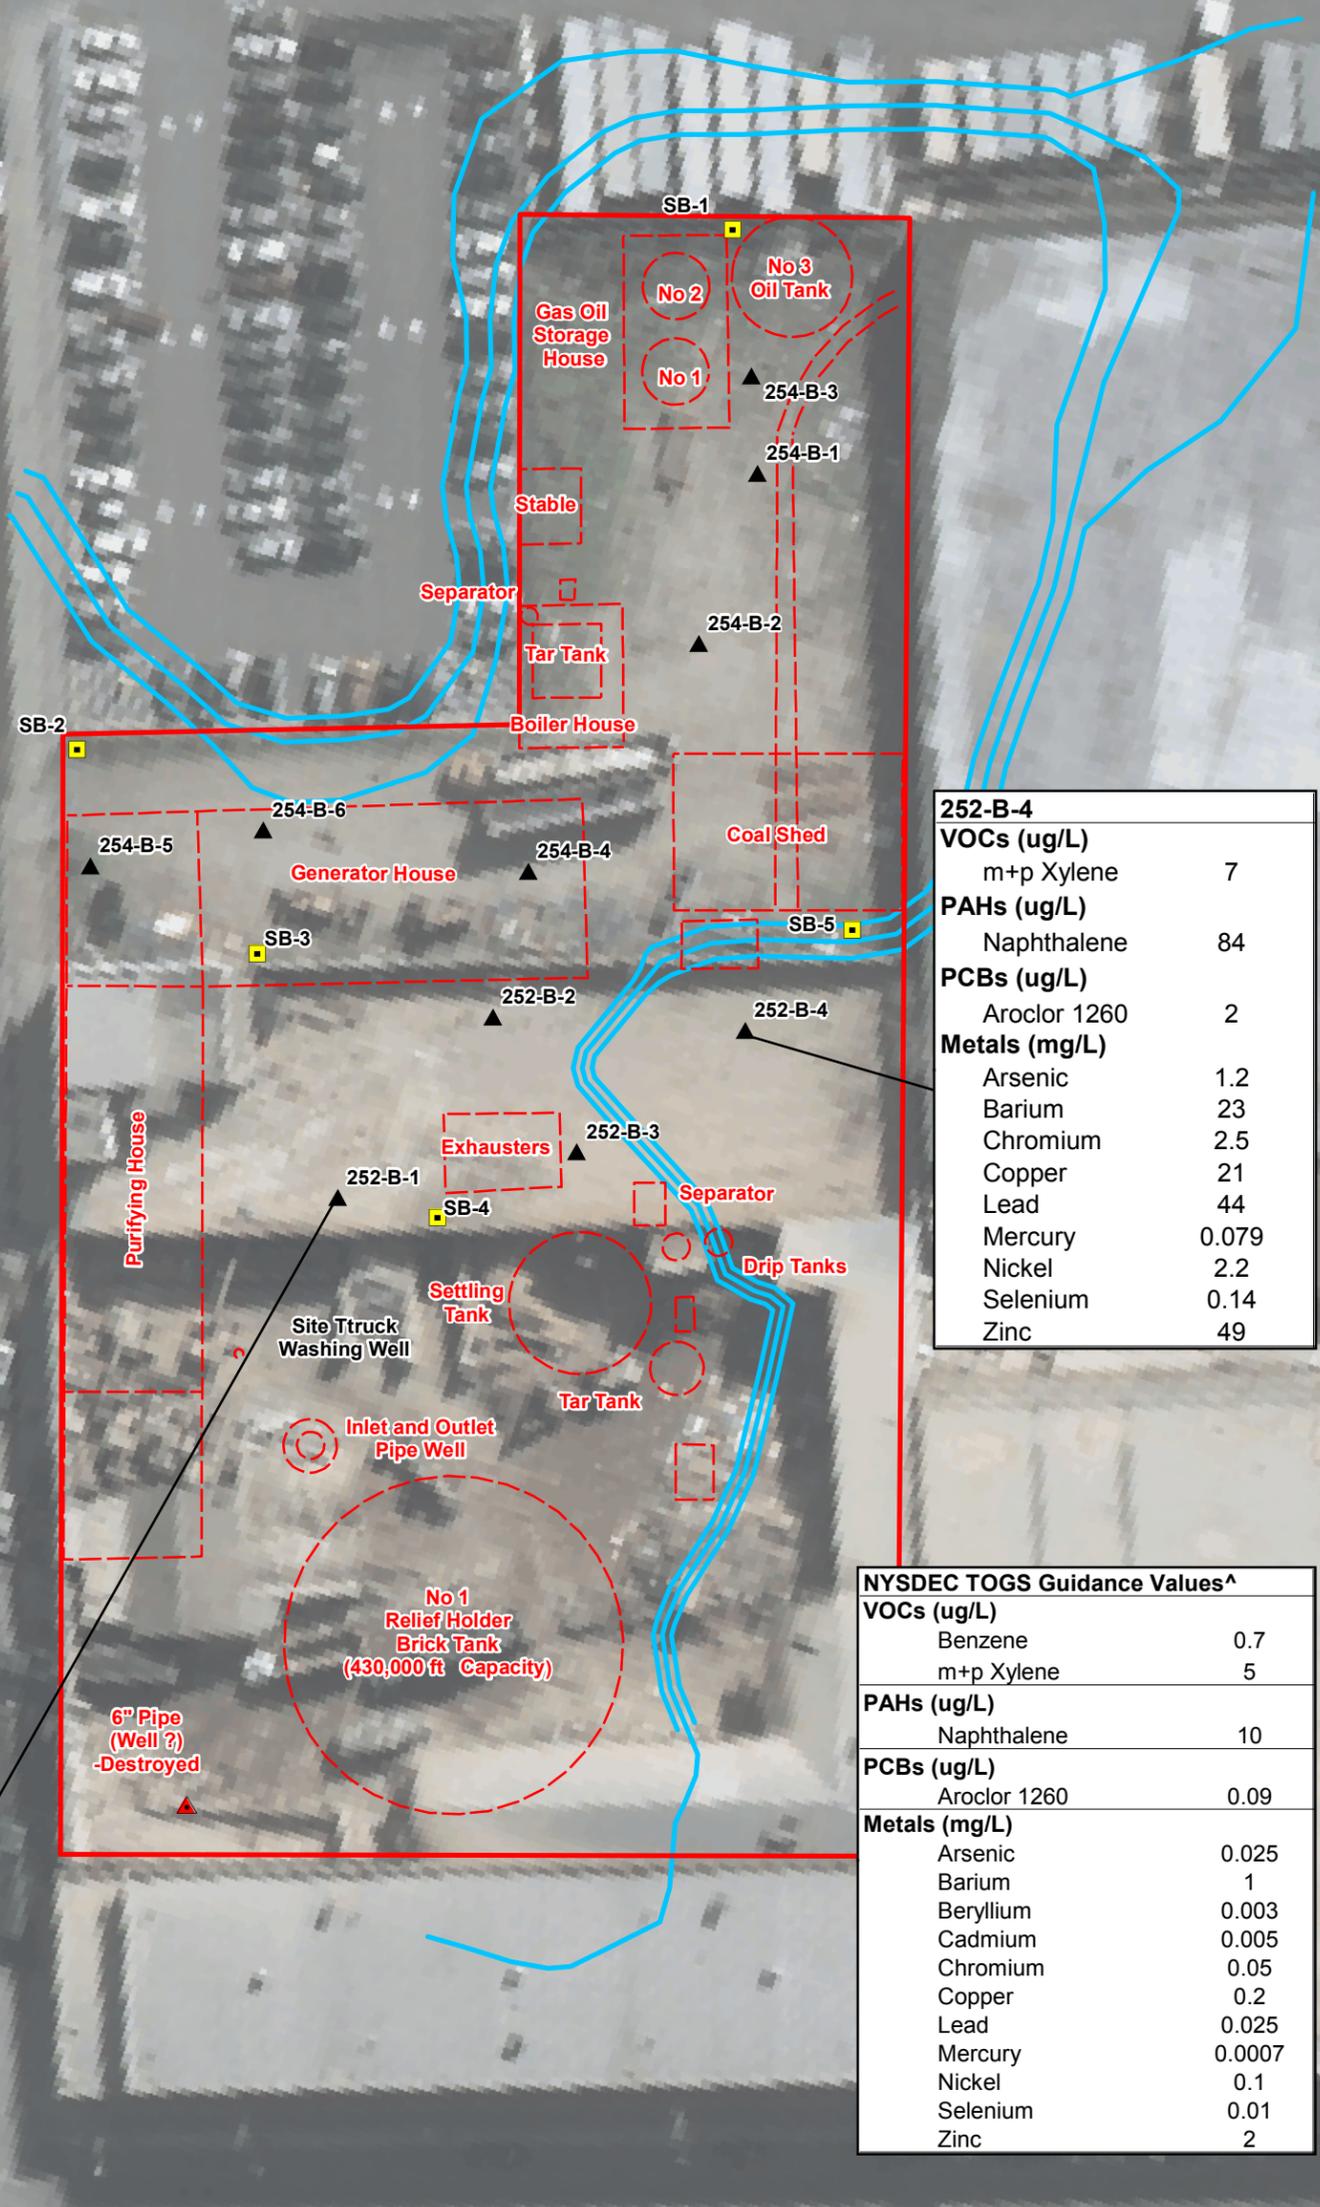
252-B-1	
VOCs (ug/L)	
Benzene	1
Metals (mg/L)	
Arsenic	2.3
Barium	39
Beryllium	0.06
Cadmium	0.52
Chromium	3.3
Copper	45
Lead	130
Mercury	0.26
Nickel	2.6
Selenium	0.16
Zinc	130

252-B-4	
VOCs (ug/L)	
m+p Xylene	7
PAHs (ug/L)	
Naphthalene	84
PCBs (ug/L)	
Aroclor 1260	2
Metals (mg/L)	
Arsenic	1.2
Barium	23
Chromium	2.5
Copper	21
Lead	44
Mercury	0.079
Nickel	2.2
Selenium	0.14
Zinc	49

Tables 2-2 and 2-3 provide summaries of the analytical results that exceed the following NYSDEC criteria: 1) for soil, 6 NYCRR Subpart 375-6 (Part 375) Commercial Use and Industrial Use Soil Cleanup Objectives; and 2) for groundwater, Ambient Water Quality Standards and Guidance Values and Groundwater Effluent Limitations (TOGS 1.1.1) (NYSDEC, 1998). The sample locations where the exceedances were observed in soils are illustrated on Figure 2-4. The sample locations where the exceedances were observed in groundwater are illustrated on Figure 2-5.

Groundwater exceedances for organic constituents were limited to: benzene (1 location); m, p xylenes (1 location); naphthalene (1 location); and PCBs (1 location). Metals exceedances in groundwater were observed at two locations in the center of the site. It is important to note that PCBs and many of the metals detected are not typically associated with MGP residuals and may be artifacts of more recent site use and suspected turbidity in the previous groundwater grab samples.

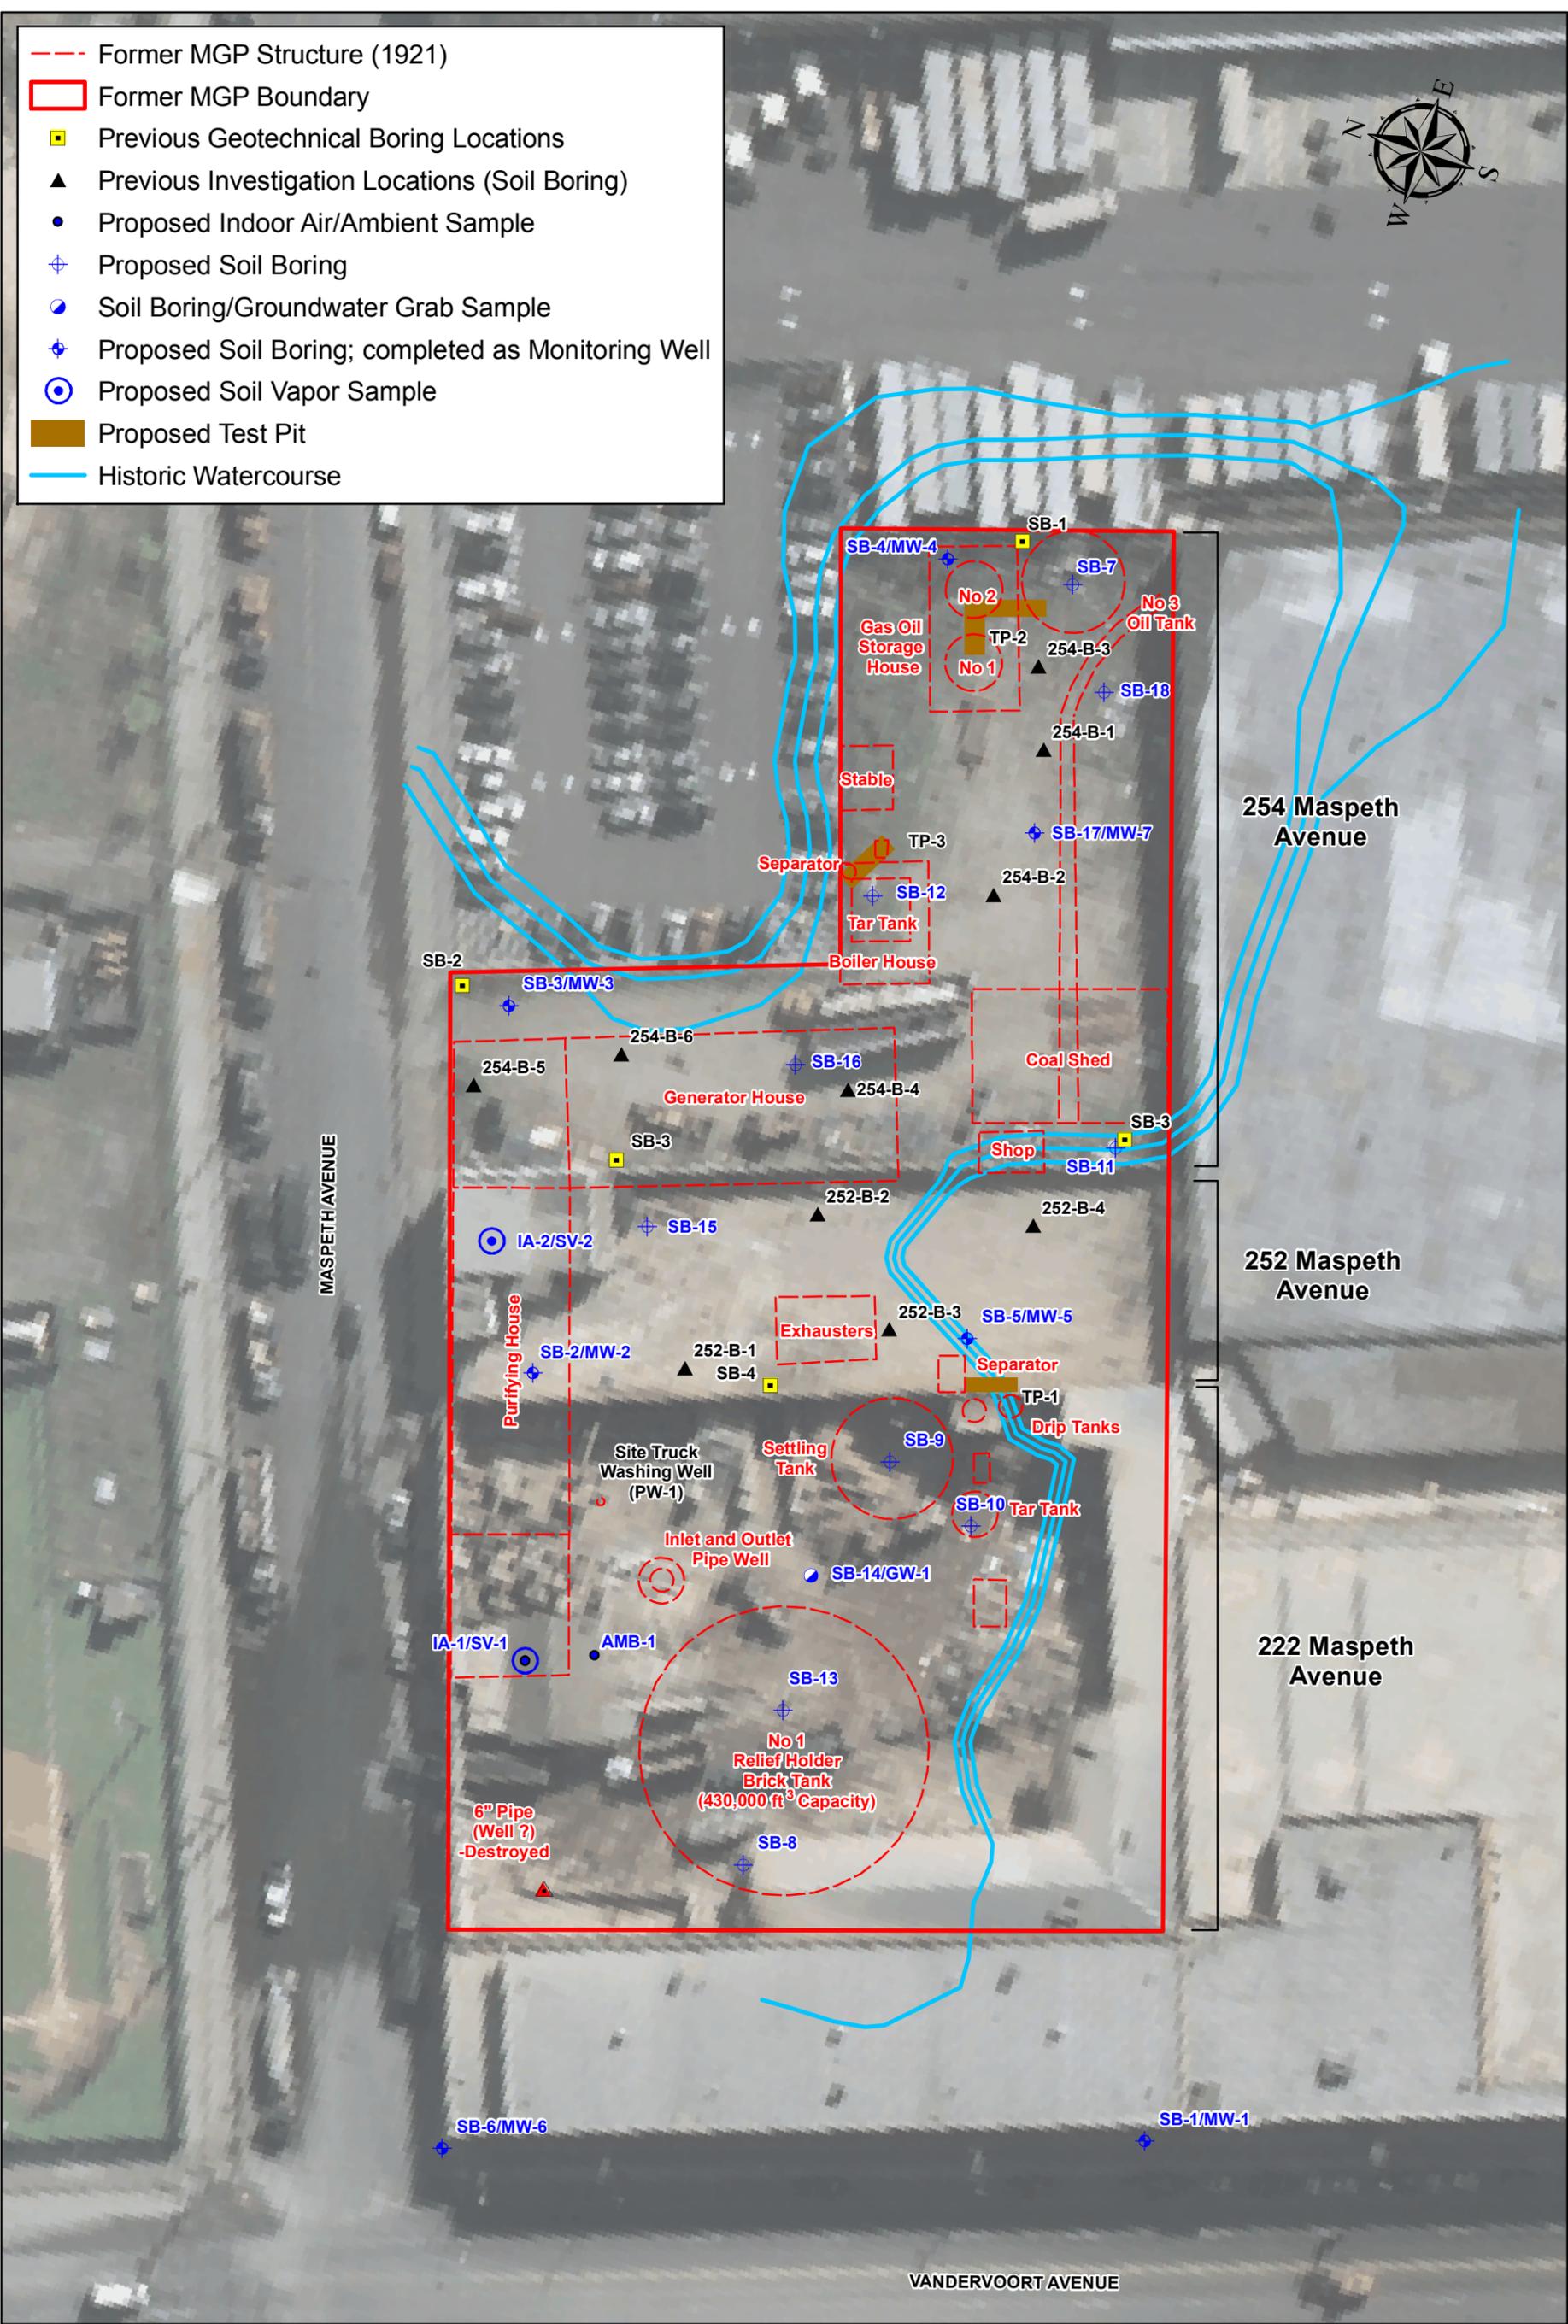
- Former MGP Structure (1921)
- Former MGP Boundary
- Previous Geotechnical Boring Locations
- ▲ Previous Investigation Locations (Soil Boring)
- Proposed Indoor Air/Ambient Sample
- ⊕ Proposed Soil Boring
- Soil Boring/Groundwater Grab Sample
- ⊕ Proposed Soil Boring; completed as Monitoring Well
- ⊙ Proposed Soil Vapor Sample
- Proposed Test Pit
- Historic Watercourse

Monitoring wells will be installed at 7 of the proposed RI soil boring locations. The monitoring well locations, shown on Figure 3-1 and detailed on Table 3-1, were selected to have a sufficient number of wells to evaluate groundwater within the former site boundary and in areas that are considered upgradient of the site. Proposed well location MW-6 is also designed to provide preliminary information related to the source of the observed product in the intersection of Maspeth and Vandervoort Avenues that was reported in two spill incidents in 2007 (refer to Section 2.4). In general, the groundwater monitoring wells will be installed at two depth intervals: the water table (estimated to be screened from 5 to 15 feet bgs) so that the screen straddles the water table; and from approximately 20 to 30 feet bgs in the intermediate portion of the upper aquifer to allow the screen to straddle the most impacted soil layers noted in the available geotechnical borings. Depths of the intermediate zone wells will be adjusted, if needed, to screen the surface of the reported clay layer noted in the on-site pumping well at approximately 30 feet bgs. In addition, three deep wells (estimated to be screened from approximately 40 to 50 feet bgs) below the reported clay layer (if laterally continuous) are also proposed to provide good lateral coverage across the site area to evaluate the lower sand aquifer screened at the on-site pumping well. If required, these wells will be installed with isolation casing in areas where shallower impacts are noted. Actual well design will depend on site conditions encountered, such as: thickness of the saturated zone; observed stratigraphy; and the presence, location, and thickness of NAPL, if any. Significant changes to the design presented in this Work Plan will be discussed with NYSDEC prior to implementation.

The proposed sampling plan consists of the concurrent collection of a total of 6 samples (2 sub-slab vapor samples, 1 duplicate, 2 indoor air samples, and 1 ambient air sample) to evaluate conditions in the scale house at the transfer facility on 222 Maspeth Ave and the maintenance garage on 252 Maspeth Ave. The scale house and the maintenance garage are the two most enclosed structures at the facility, and they are occupied intermittently throughout the day. The sampling will be preceded by a chemical inventory check within these buildings. The approximate sampling location for the two indoor air / sub-slab vapor samples are shown on the Figure 3-1.

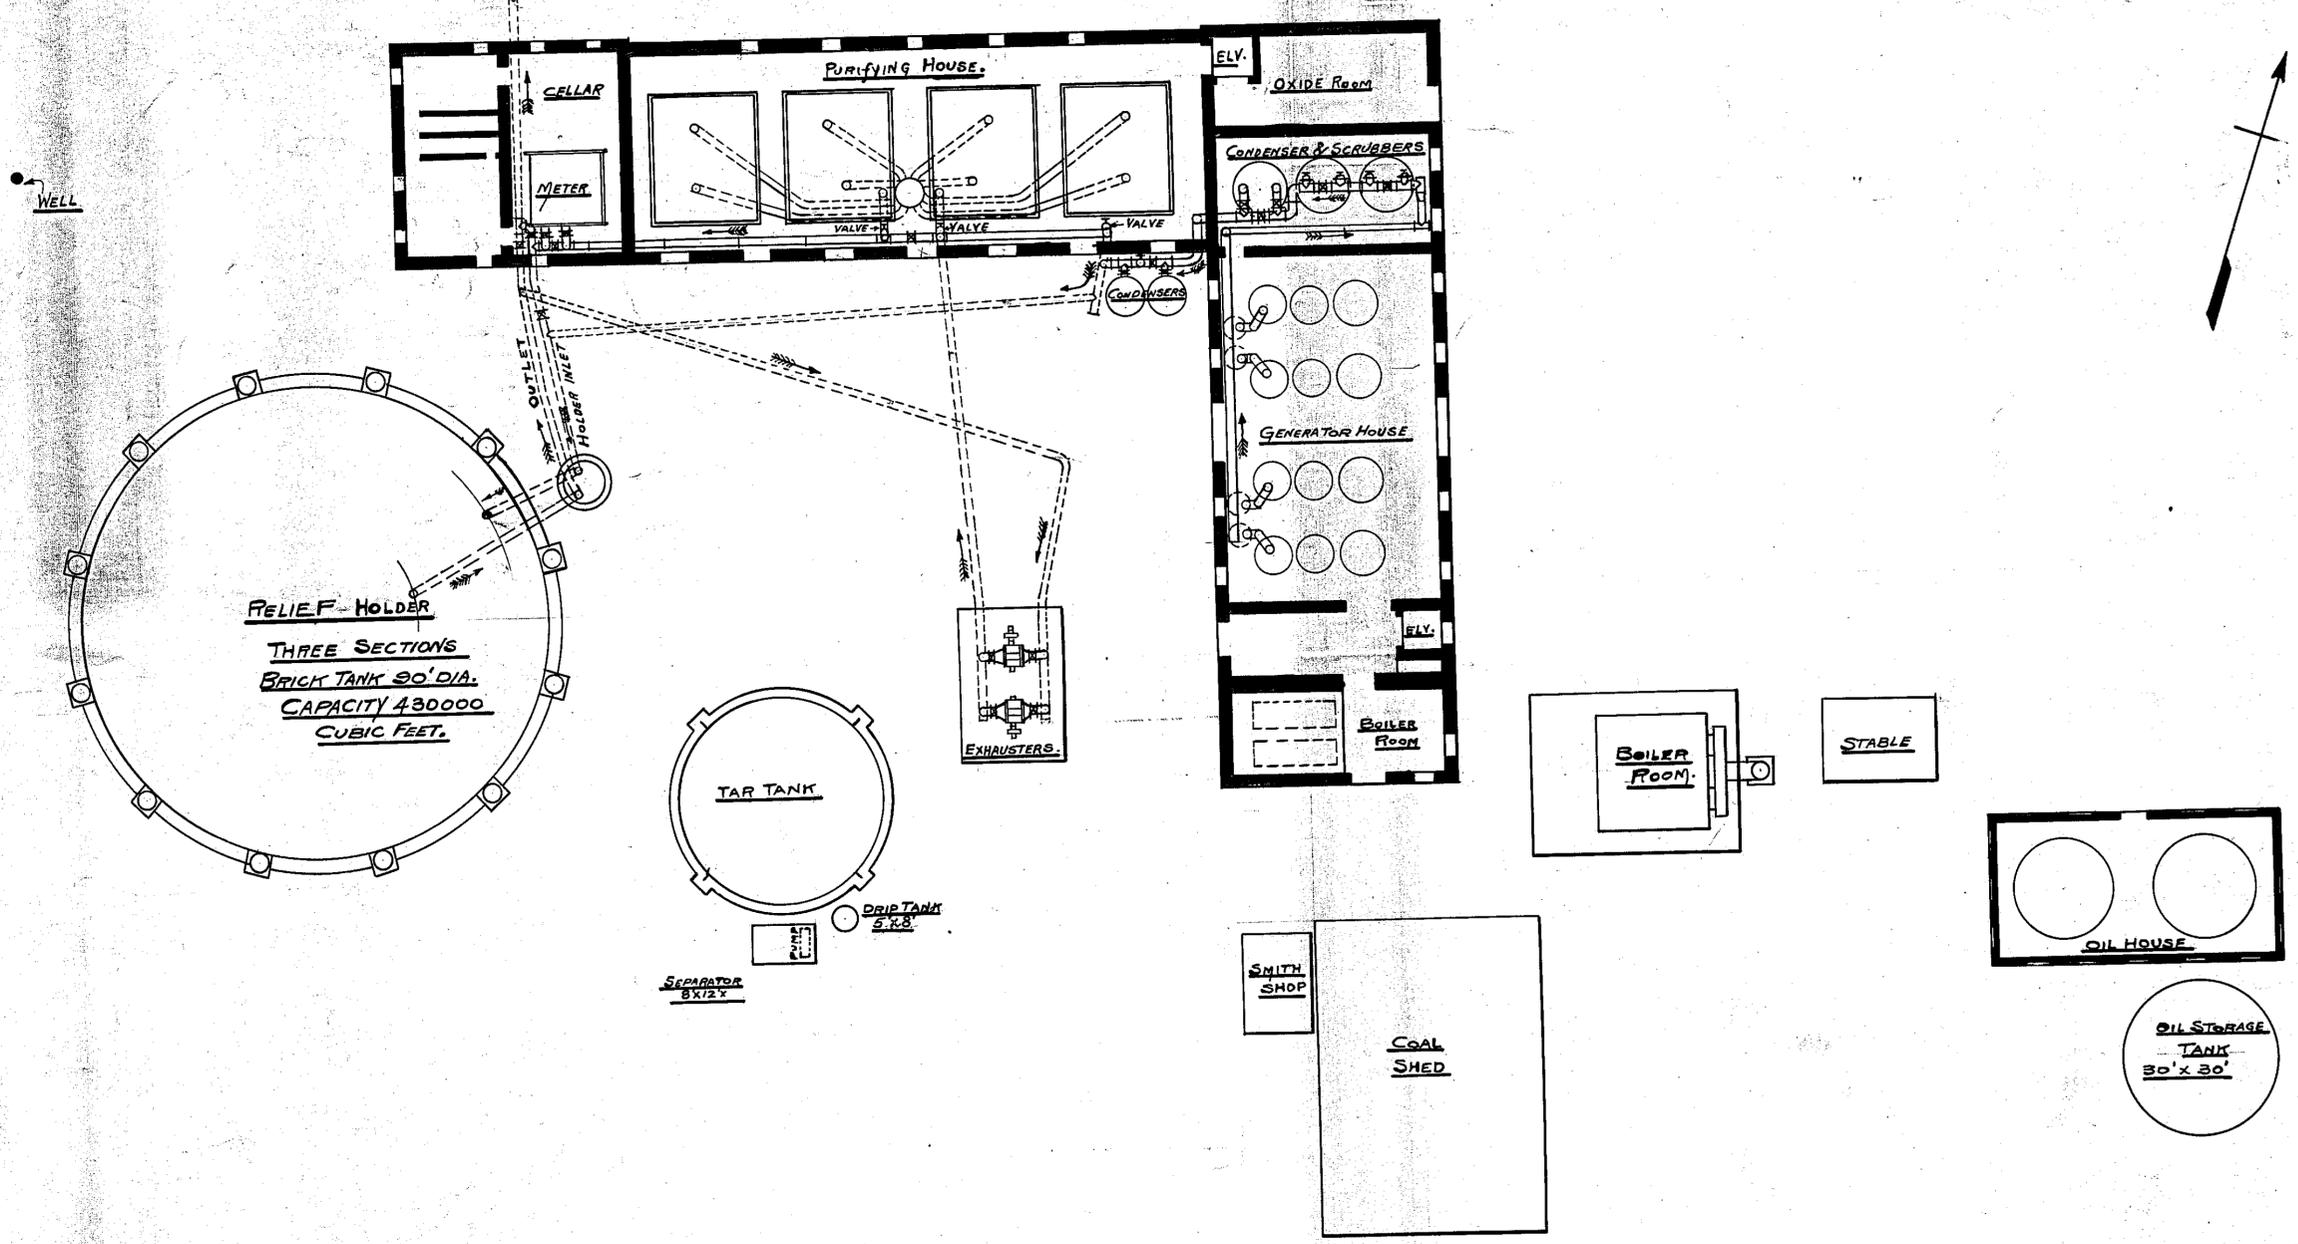
BROOKLYN UNION GAS CO.

PLAN OF EQUITY WORKS

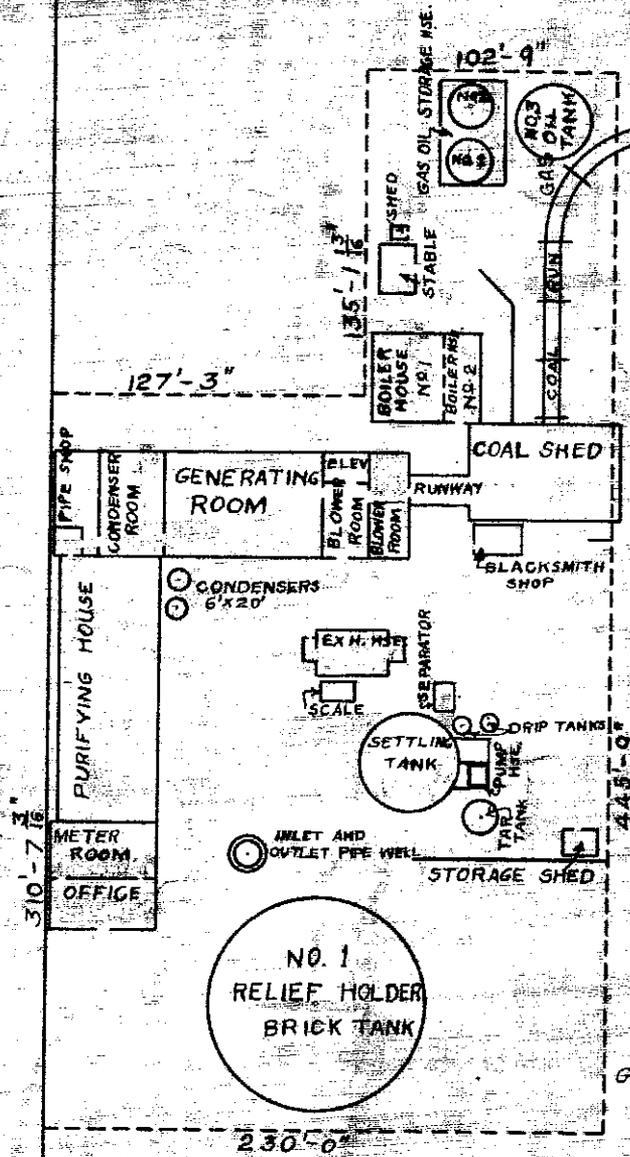
INSIDE DIMENSIONS

Stable	Frame	20'-6" x 15'-4" x 14' high
Boiler Hse.	Steel/Wood Frame	39'-0" x 28'-6" x 18'
"	" No. 2 "	Steel " 15'-0" x 39'-0" x 28'-6"
Coal Shed	Steel Frame	40'-0" x 60'-0" x 9'
Blacksmith shop	Wood	14'-4" x 13'-6" x 10'
Coal Run	Wood	
Coal Runway	Galv. Ir. Wood Frame	26'-0" x 11'-0" x 8'
Blower Room	Brick	42'-2" x 31'-0" x 12'
Generating "	"	42'-2" x 66'-0" x 24'
Condenser "	"	22'-6" x 42'-6" x 24'
Pipe Shop	"	18'-0" x 42'-6" x 24'
Purifying Hse.	"	39'-8" x 116'-8" x 22'
Meter Rm.	"	40'-0" x 21'-11" x 24'
Office	"	19'-9" x 19'-3" x 24'
Exhauster Hse.	Wood	29' x 19'-0" x 18'-6"
Storage Shed	Wood	10'-0" x 15'-2"
Pump Hse.	Wood	10' x 8'
Gas Oil Storage	Brick Hse.	26'-0" x 53'-6" x 15'-0"
Gas Oil Tank No. 1		20' x 12'
" " " " 2		20' x 12'
" " " " 3		30' x 30'
Tar Tank		14' x 14'

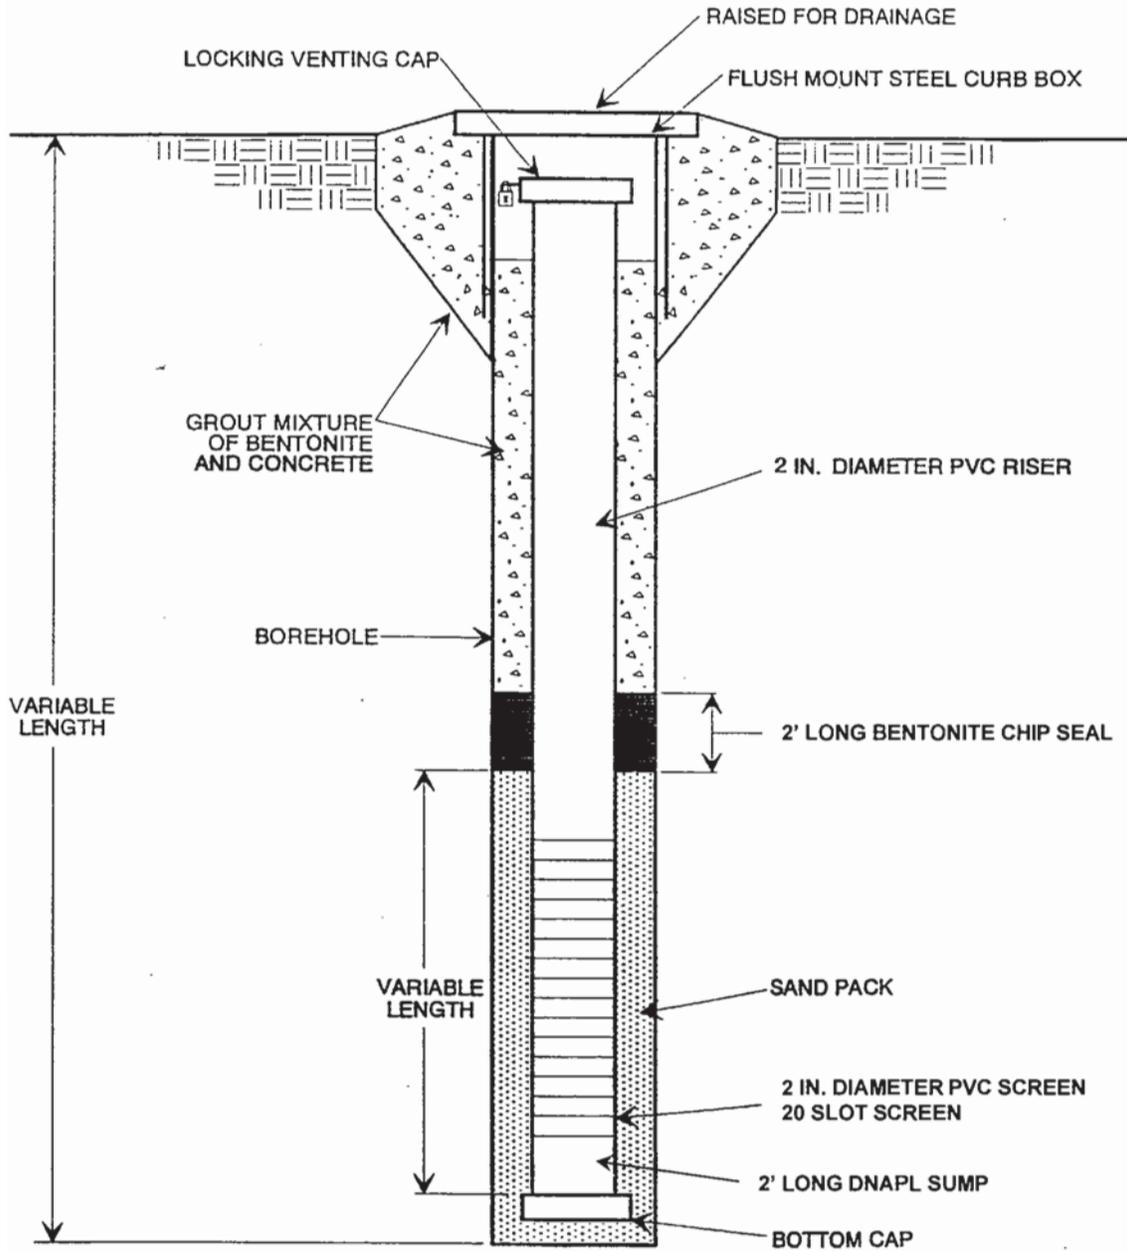
Figure 4-3

TYPICAL MONITORING WELL CROSS SECTION

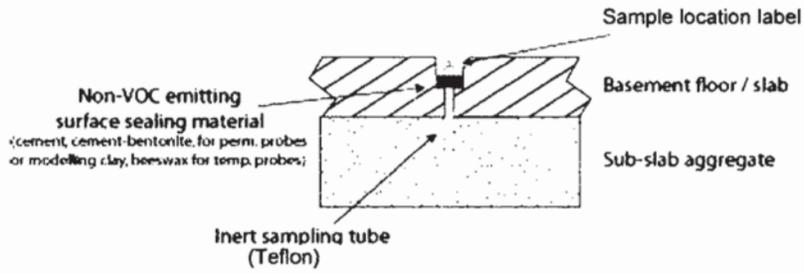
TYPICAL SUB-SLAB SAMPLING PROBE SET UP

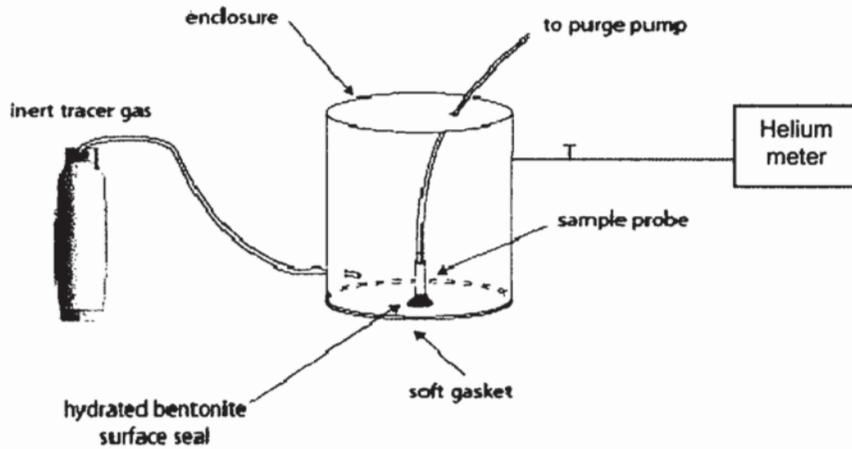
TYPICAL HELIUM TRACER TEST SET UP

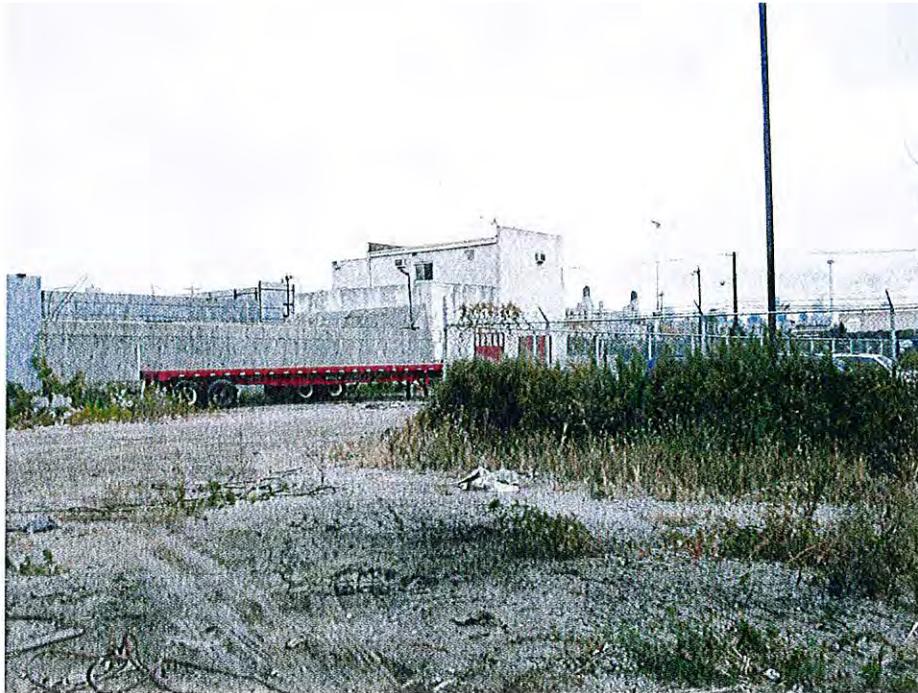
View of property facing northwest surficial stains on soil

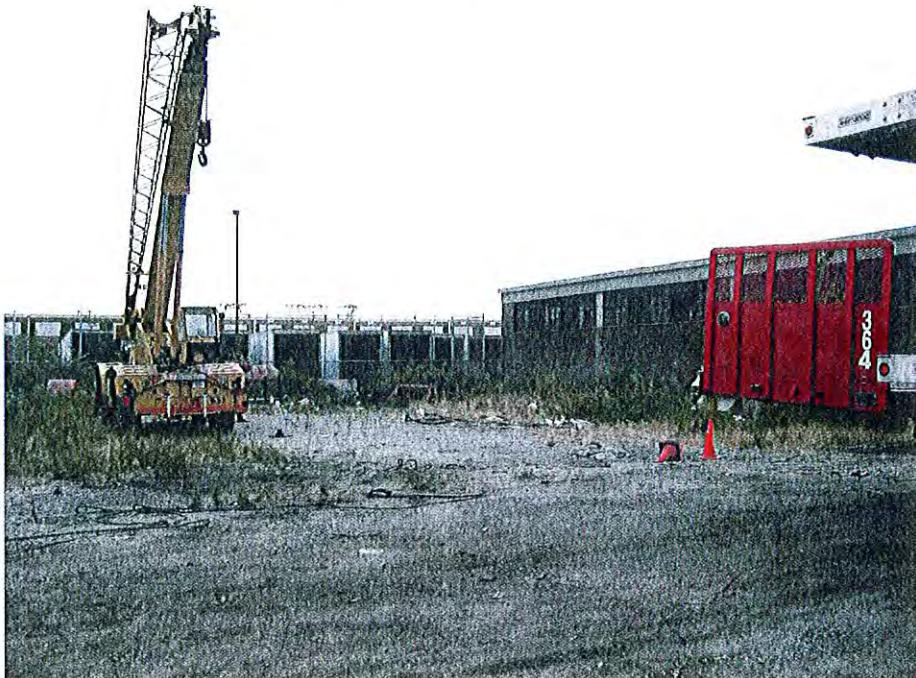
View of property facing east with crane and 5,000 gal UST

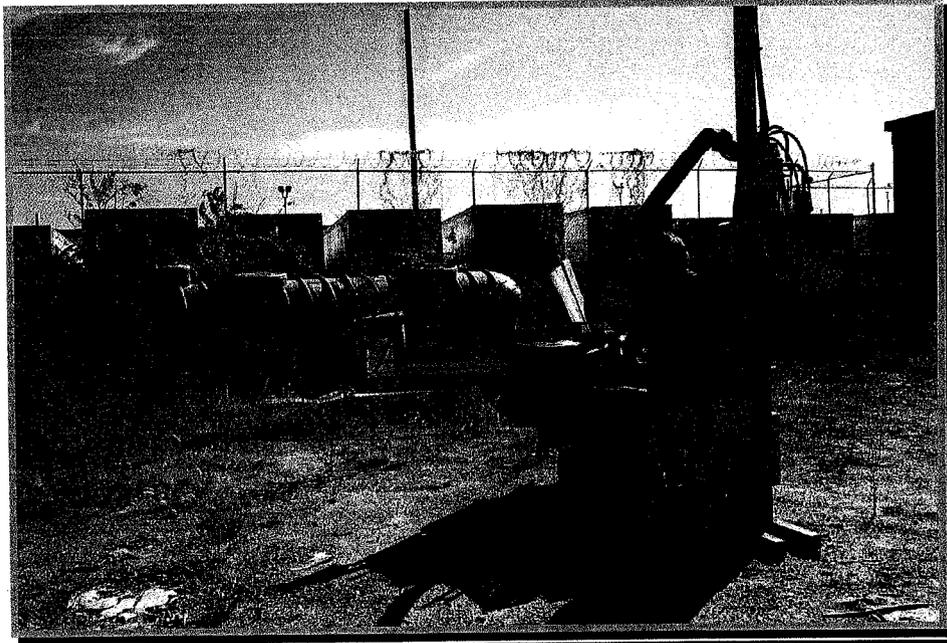
Photo 1: Advancement of soil boring B-1 on the subject property.

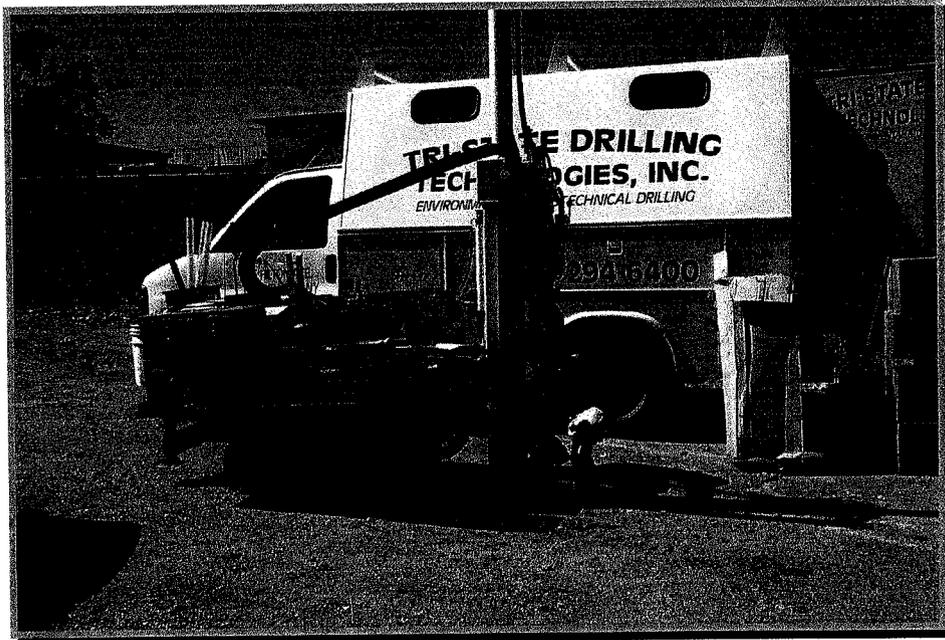
Photo 3: Advancement of soil boring B-4 on the subject property.
